# HAZARD ALERT

## Explosion and Glassware Failure

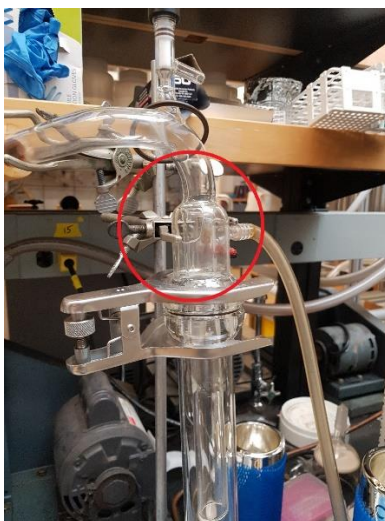
There was an incident in the department in which a liquid-nitrogen-cooled solvent trap exploded immediately after the vacuum was turned off and the Dewar was lowered.

The researchers and incident investigators believe that the explosion resulted from a crack in the glassware that resulted in air entering the trap and oxygen condensing in the trap. See photo of apparatus below. It is possible that the metal prongs of the clamps scored the glass which led to the failure.

- Ensure clamps have a plastic coating on the prongs.
- Inspect glassware for cracks.
- Position a blast shield in front of the trap.
